**PHASE I CULTURAL RESOURCES SURVEY OF
2.31 ACRES (0.94 HECTARES) NEAR
HARRISONBURG, CATAHOULA PARISH,
LOUISIANA**

Final Report

February 2021

**Surveys Unlimited Research Associates, Inc. P.O.
Box 14414
Baton Rouge, Louisiana 70898-4414**

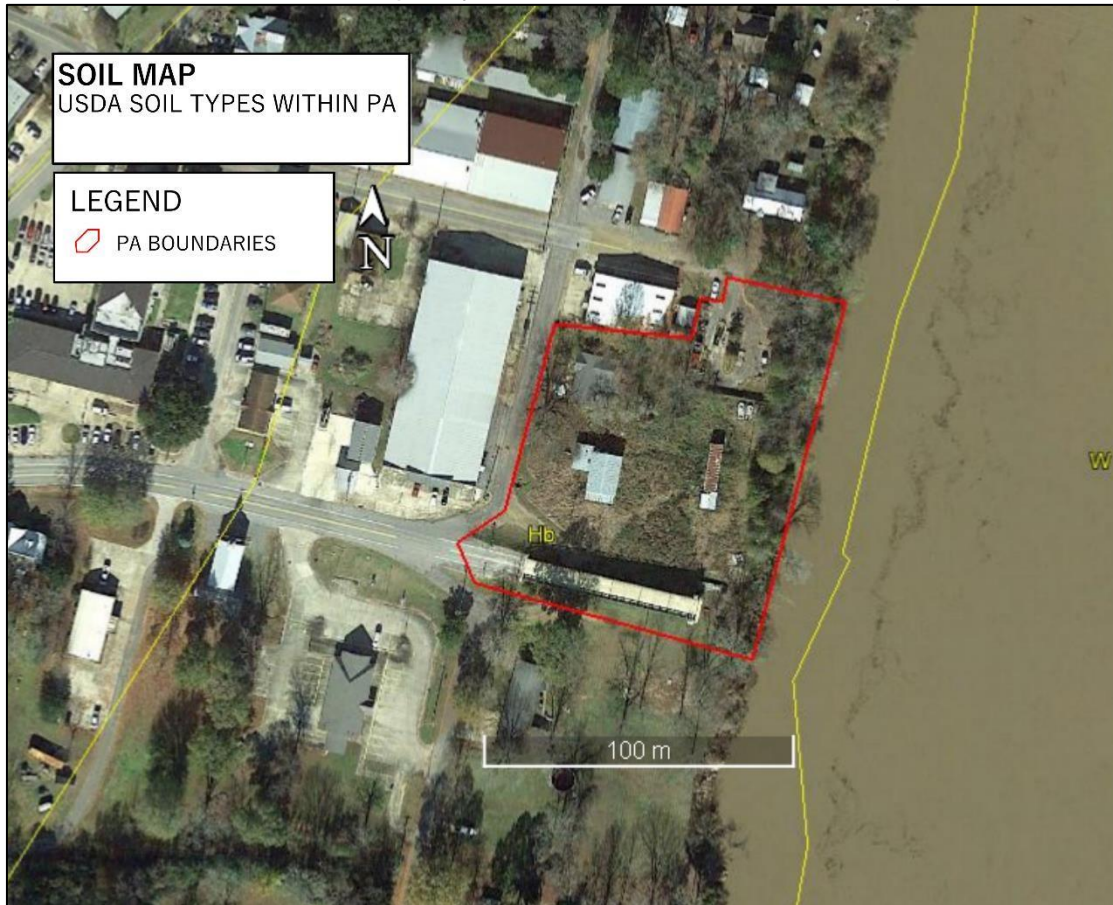
Figure 2. Soil map of PA (University of California, Davis 2016/Google Earth).

The PA is composed of one soil type, Herbert silt loam (Figure 2). This soil type is found on natural levees and is somewhat poorly drained. This soil is considered prime farmland.

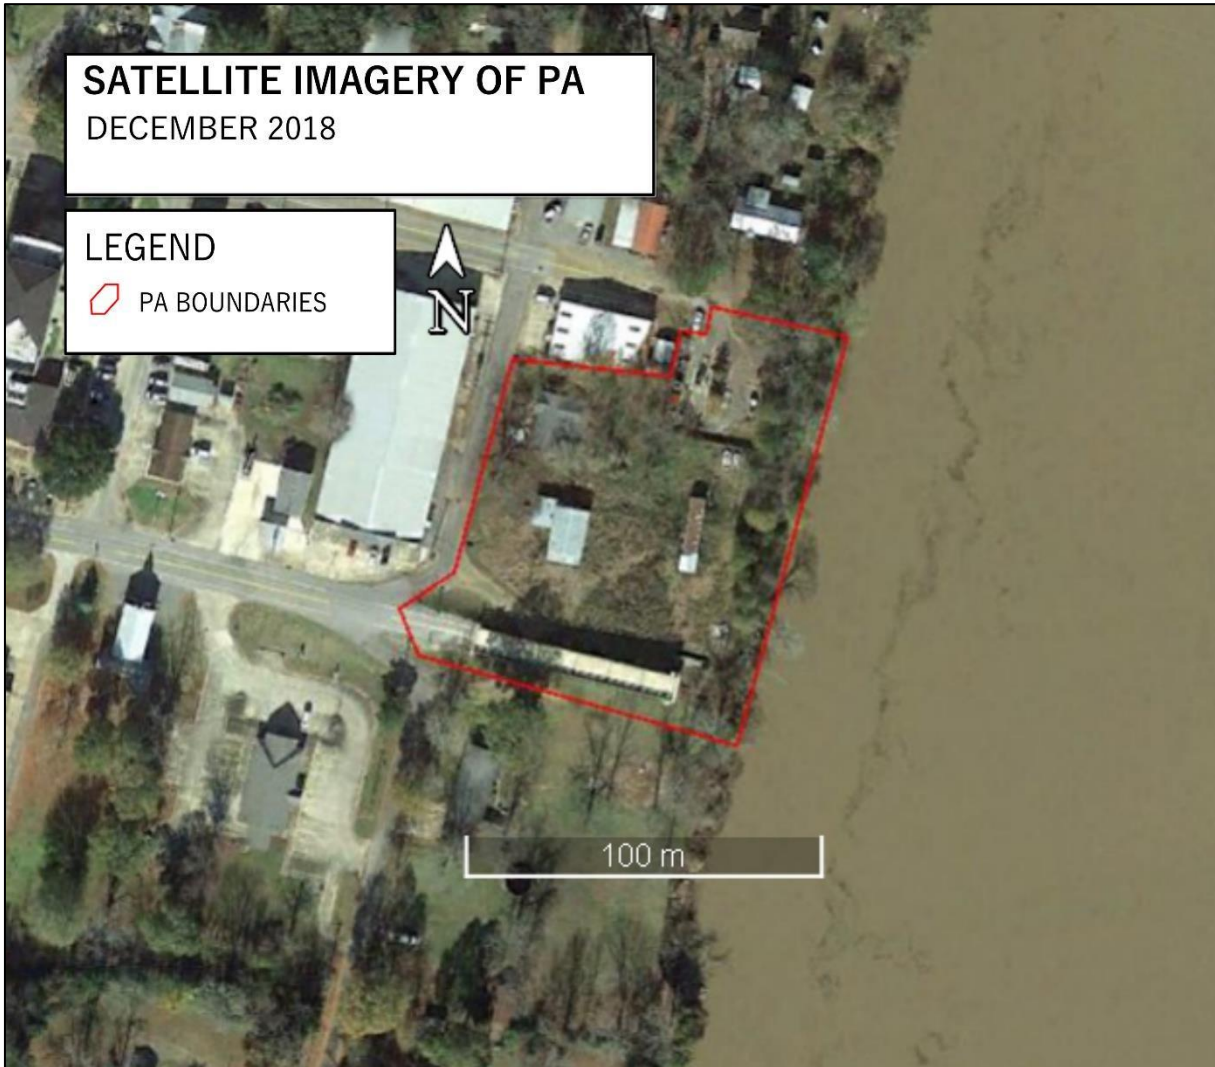
Figure 8. Aerial Photograph of PA, December 2018 (Google Earth).

In 2018, the two structures are visible as well as the mobile home (Figure 8). The lot appears to be slightly more overgrown than in the previous image, and the gravel driveway is now obscured by grass. The Long-Allen bridge has now been decommissioned and only the on ramp remains along the southern boundary of the PA.

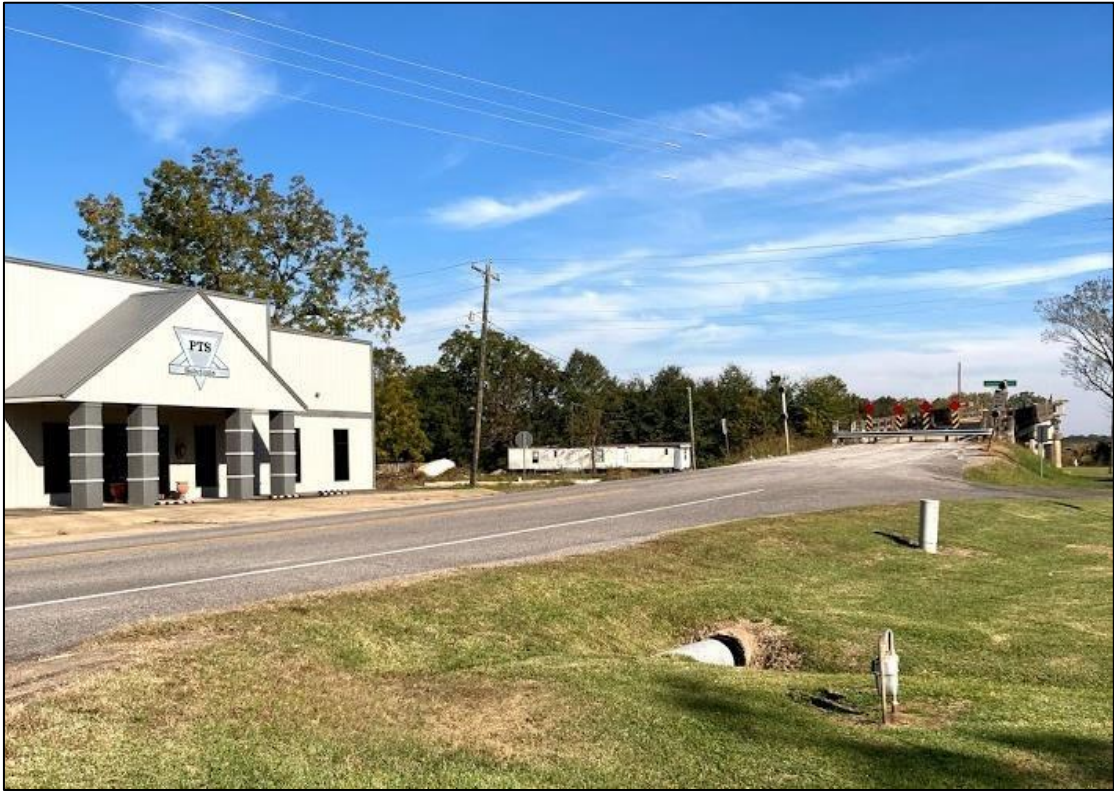
Figure 12. Harrisonburg Methodist Church (13-00596) viewshed, northeast, facing PA.

The three standing structures within the indirect PA were assessed and assigned Louisiana Historic Resource Inventory ID numbers. The PA is within the viewshed of the Harrisonburg Methodist Church (Figure 12).

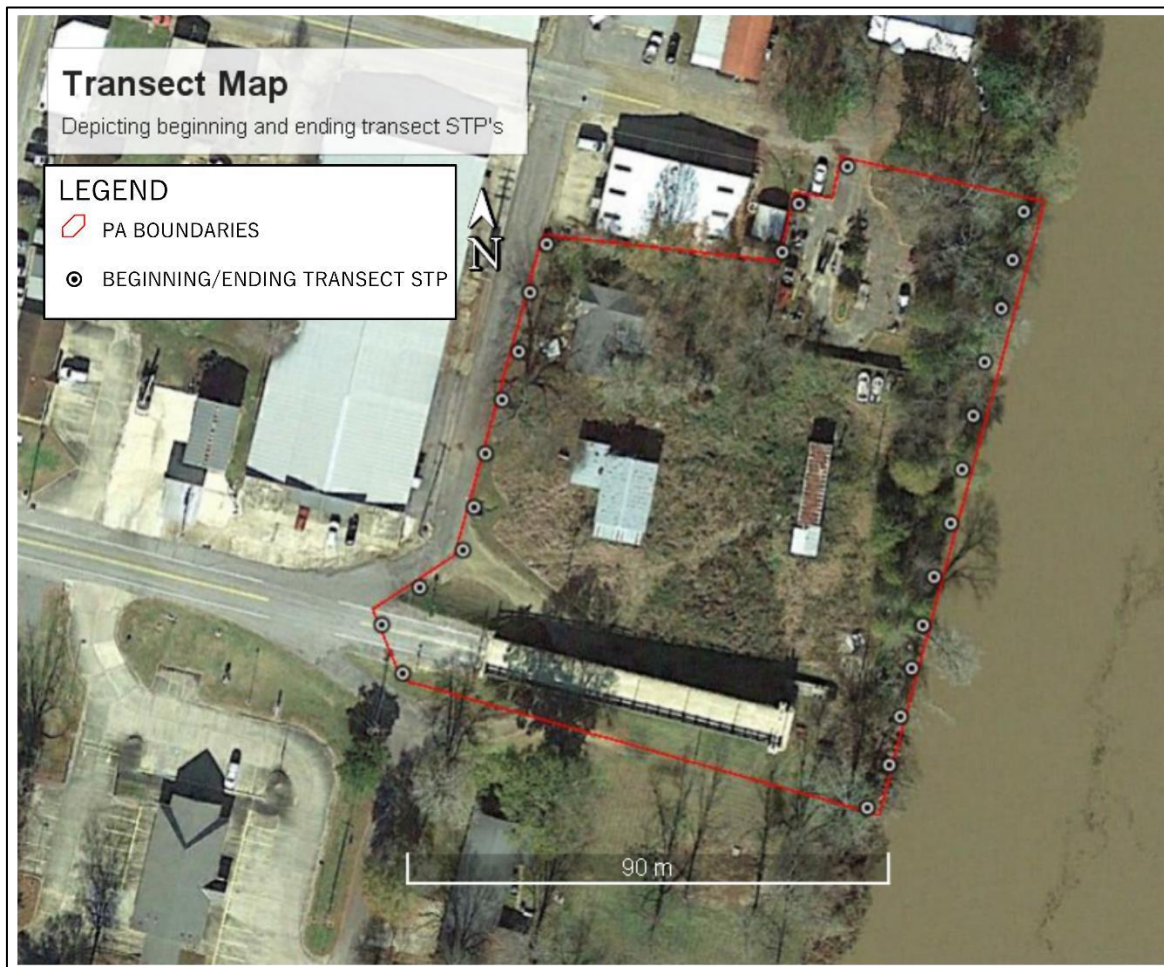
Figure 14. Aerial photograph depicting shovel tests and transects of the PA (Google Earth).

Field survey was conducted from November 4th to 5th, 2020. The PA consisted of a residential plot within the village of Harrisonburg, Louisiana. A total of seventy-four transect shovel tests were excavated during the initial survey (Figure 14). Four delineation shovel tests were also excavated at five-meter intervals during site definition, along with three trenches. Figures 15-21 show examples of disturbances within the PA and its present use. Table 4 depicts representative Munsell soil profiles for the PA.

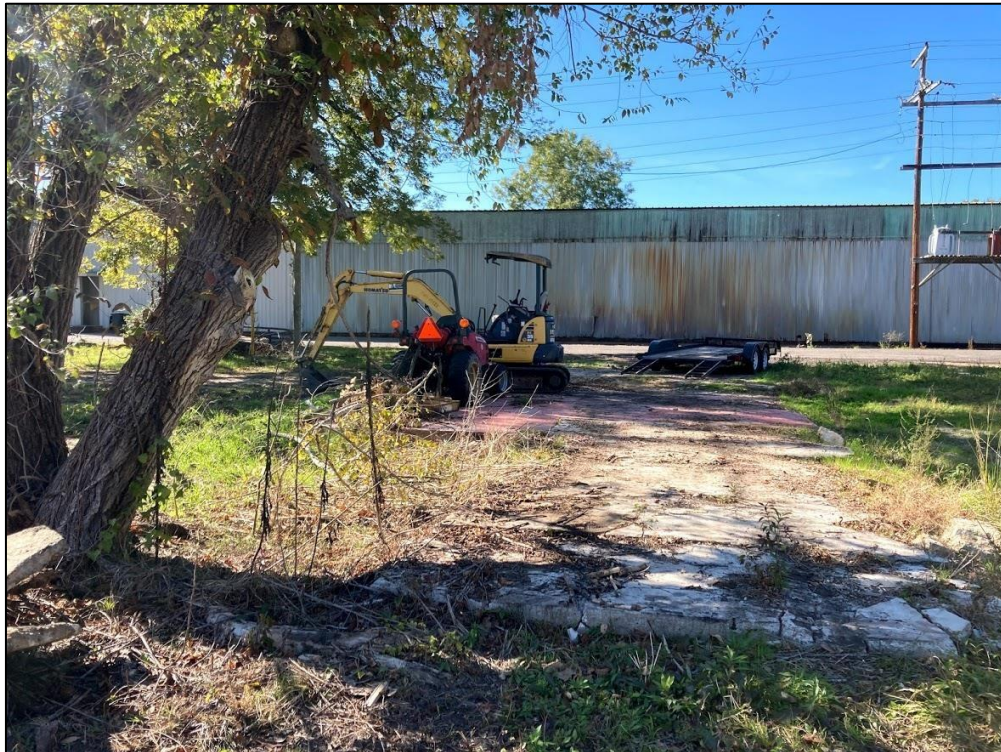
Figure 27. Locus 1 facing west.

One site was identified within the PA, CS House Pads (16CT547) (Figure 22). CS House Pads (16CD547) consists of 6 loci: Loci 1-3, which are composed of concrete house foundations, Locus 4, a trench positive for subsurface historic artifacts, Locus 5, a concentrated surface scatter of historic artifacts with no subsurface component, and Locus 6, a positive shovel test that yielded historic materials. The site boundaries are depicted in figure 13. The house pads that comprise Loci 1-3 are depicted on the USGS Topographic Quadrangle from 1959. This quadrangle is depicted in Figure 23.

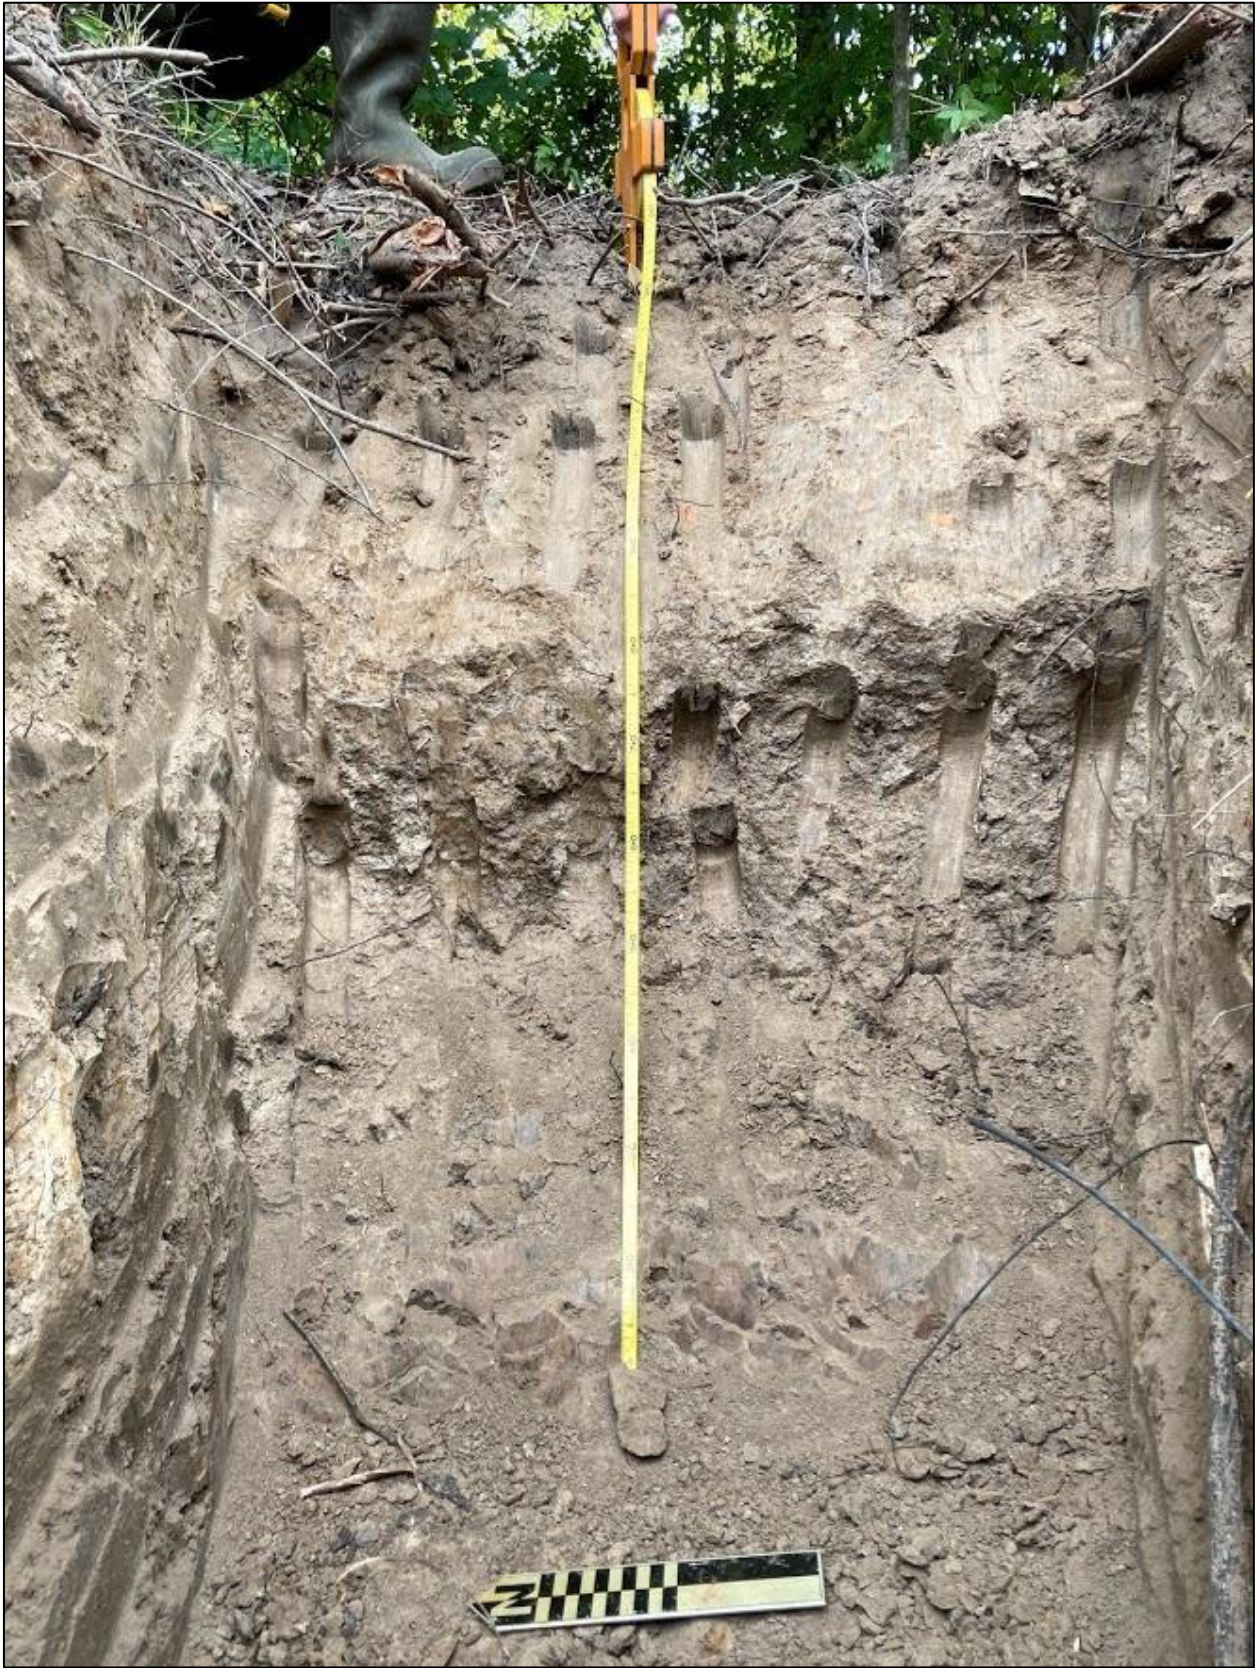
Figure 30. Eastern wall profile of Locus 4.

Location	Depth	Munsell	Description
Locus 4	0-20 cmbs	10 YR 4/1	Silty Loam
	20-65 cmbs	10 YR 4/4	Sandy Silt
	65-130 cmbs	10 YR 5/4	Silty Clay

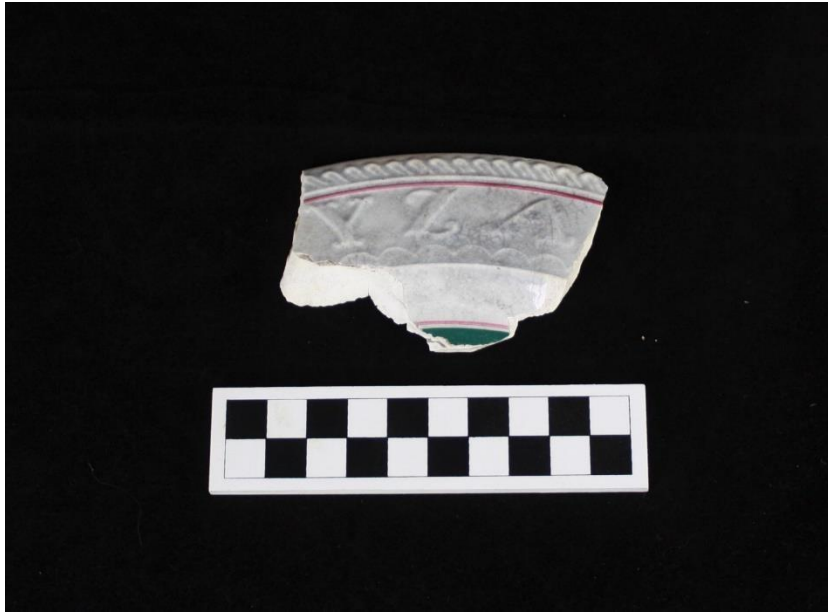
Materials collected from locus 4 include ironstone rim (n=3), stoneware base with manganese glaze (n=1), yellowware rim with blue glaze (n=1), and clear flat glass (n=1). Material collected from locus 5 include hand painted ironstone sherds (n=4), clear glass whole bottle (n=1), and white milk glass (n=1). Materials collected from locus 6 include ironstone rim with grey glaze (n=3), and stoneware base (n=1).

Figure 32. Stoneware with grey glaze recovered from Locus 6; 20 cmbs.

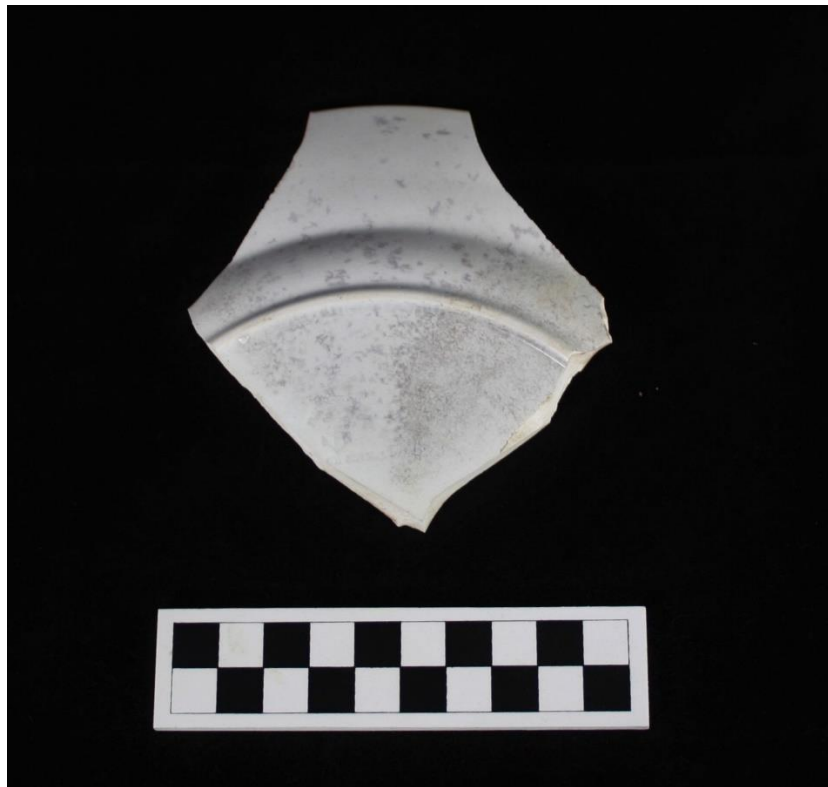
Figure 33. Ironstone base and rim recovered from Locus 4; 40 cmbs.

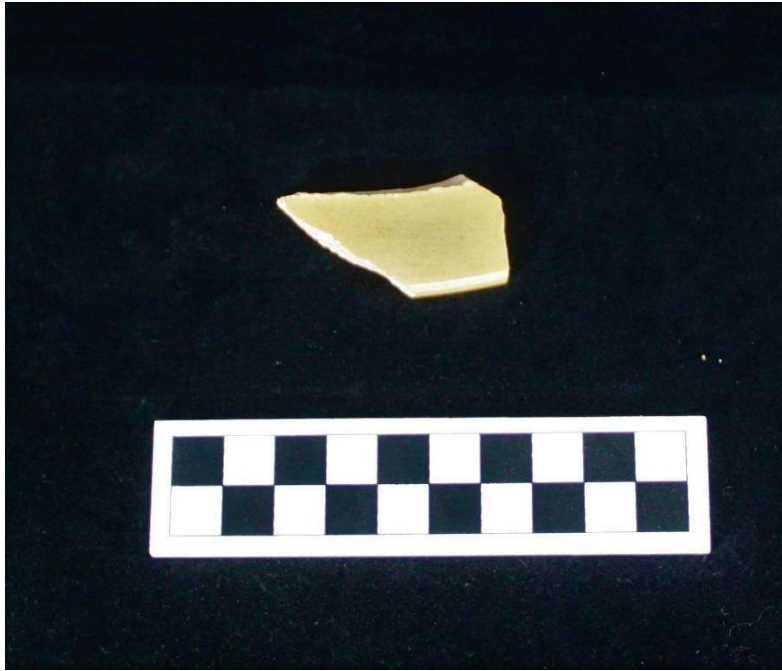
Figure 34. Yellowware rim recovered from Locus 3; 40 cmbs.

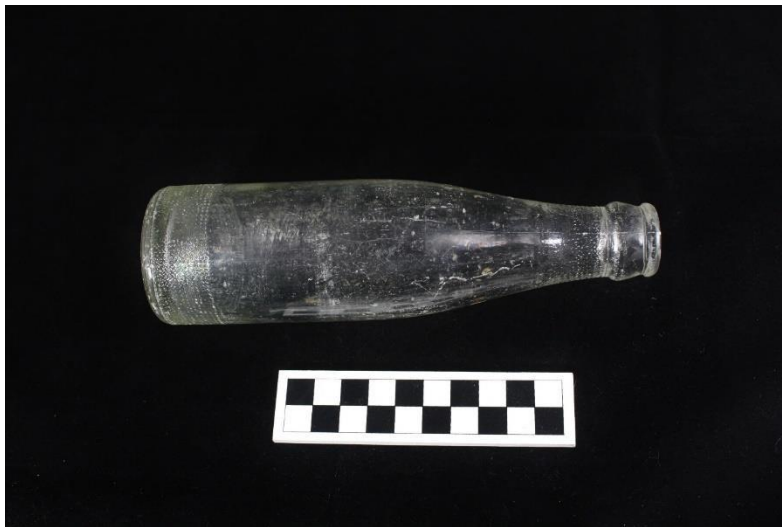
Figure 35. Clear glass bottle recovered from Locus 5; surface.

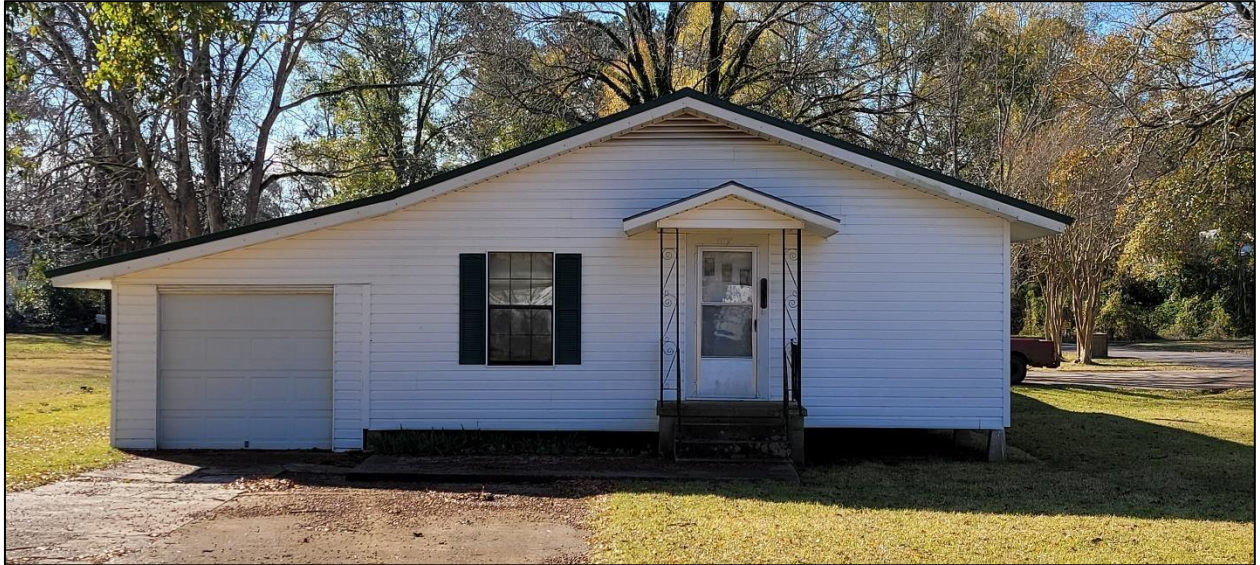
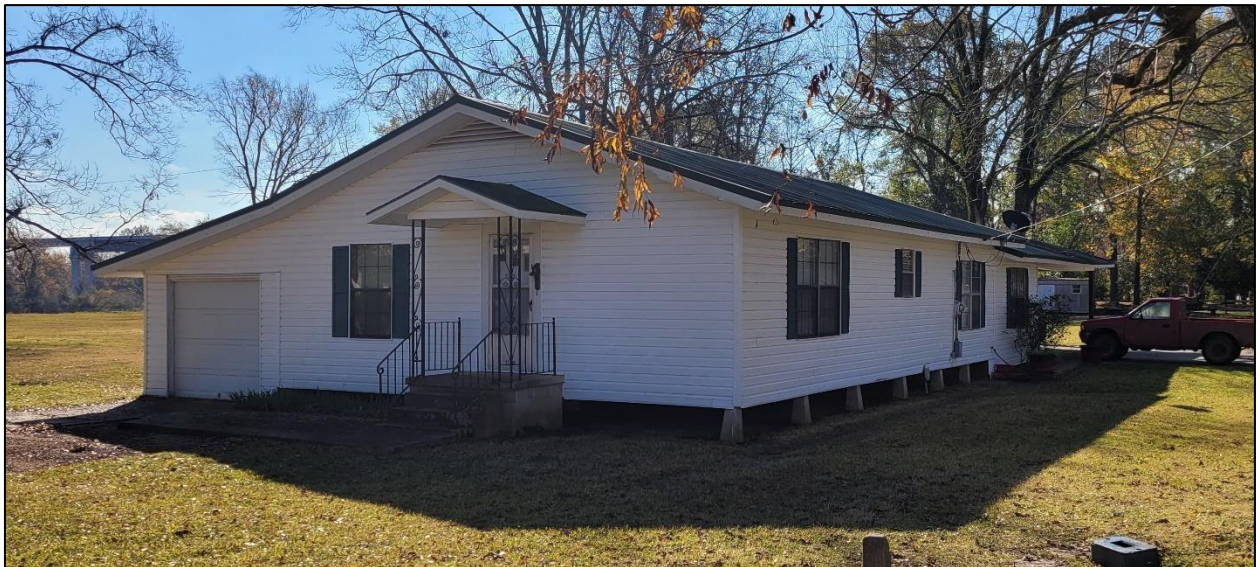
Figure 37. Structure 13-00588, facing south.

Structure 13 - 00588 is located at 302 Catahoula Street (Latitude: 31.770521, Longitude: 91.810069). The structure is a minimal traditional cottage constructed c. 1940 (Figures 37-38). The structure features a front gabled roof with secondary dropped side elevation extension over a single car garage with a metal roll up door. The building is clad in vinyl siding, has boxed eaves, is raised on concrete piers, and has 6/6 windows with applied louvered shutters. The front door sits under a small gable end roof supported by decorative metal posts that rest on a concrete landing.

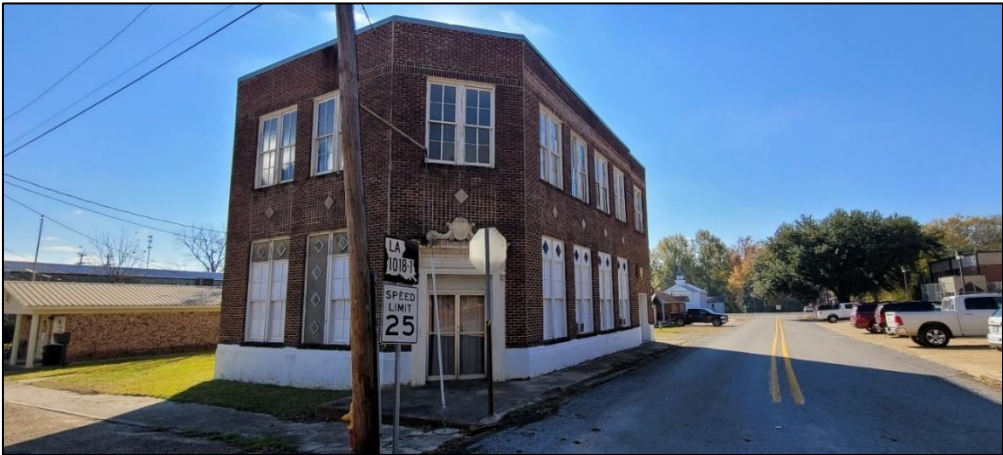
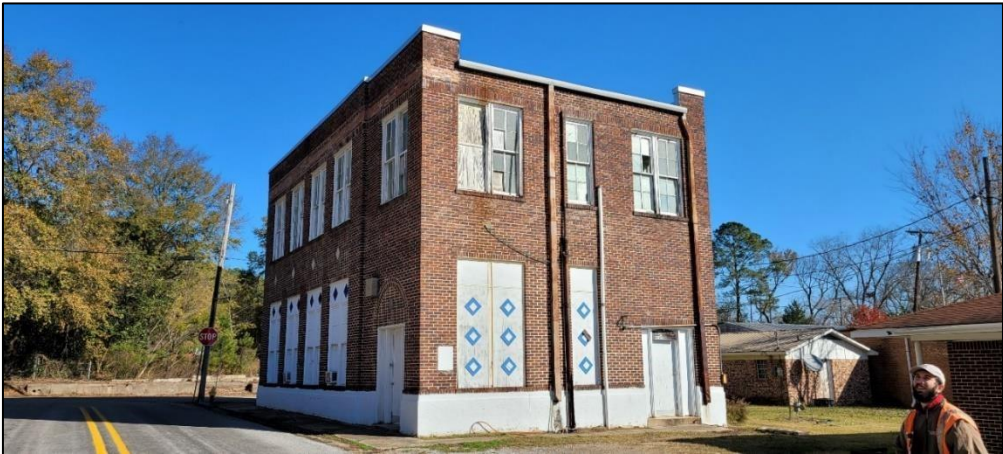
Figure 39. Structure 13-00589, facing southeast.

Structure 13-00589 is located at 103 Short Street (Latitude: 31.771892, Longitude: 91.820872). The structure is a freestanding commercial building constructed c. 1900. The structure is present on the 1919 Sanborn Map (Figures 39-40). This two-story rectangular building features clipped corner entrance. The building is clad in running bond brick. It has a flat roof with a flat parapet wall on three sides. The 4/4 dh wood windows are in sets of two; The first-floor windows have diamond appliques in the transom area and some windows are boarded up. The rear elevation entrance has a flat door with boarded up sidelights. The side elevation entrance also has a flat door that sits under a decorative brick arch filled with header bricks. The main entrance has a set of metal commercial doors with clear glass and a decorative entablature with dentil details topped with a crest.

Due to the age and style of Structure 13-00589, if federal funds are to become available for the proposed project, additional research is required to address specific eligibility criteria for this resource.

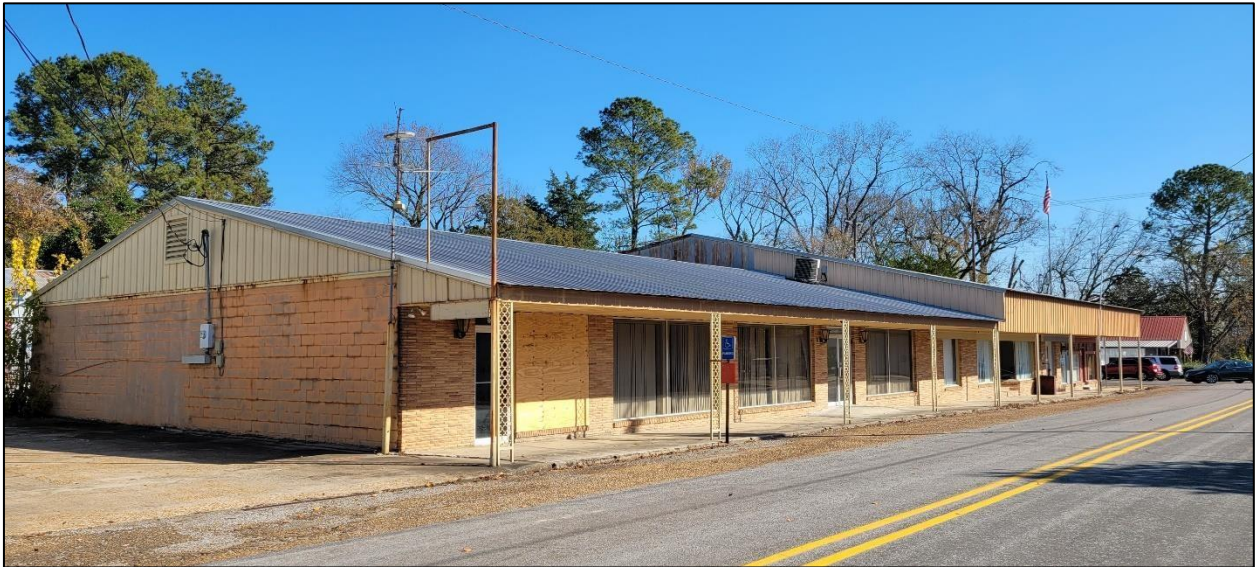
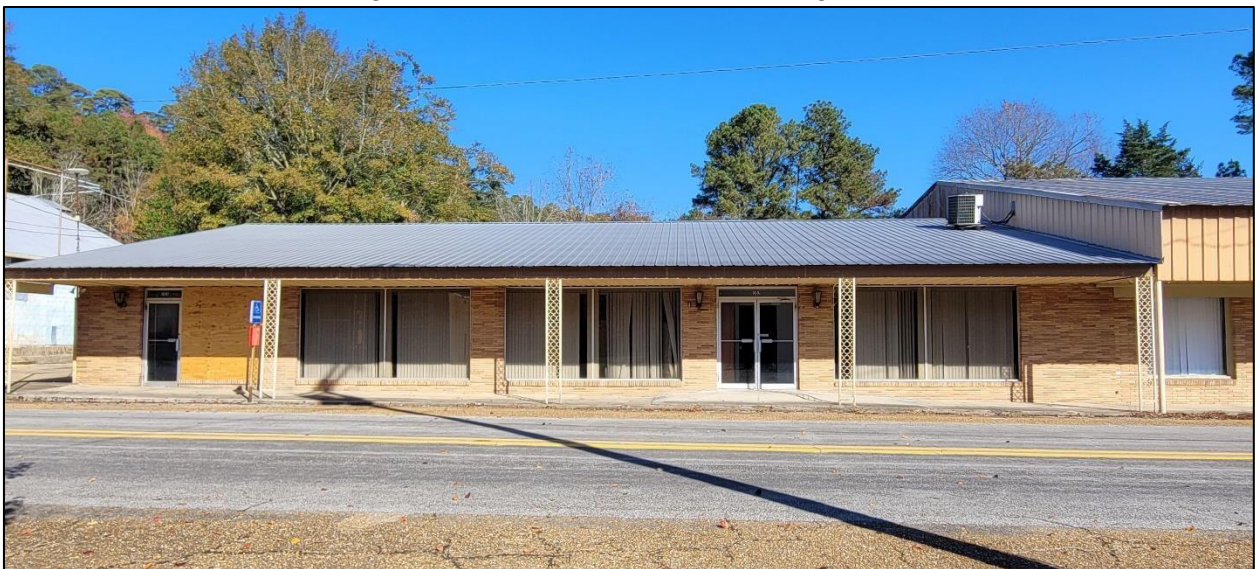
Figure 41. Structure 13-00590, facing west.

Structure-00590 is located at 202-203 Catahoula Street (Latitude: 31.772127, Longitude: -91.820341). The structure is a commercial row building constructed c. 1960 (Figures 41-42). The structure is a single-story concrete block commercial building laid on slab with a side gable roof clad in metal. The building is clad in running bond brick on the façade with metal vertical sheets in the gable ends. The full width incorporated front porch is supported by decorative metal posts. The aluminum façade openings are commercial in style: large single pane windows and doors.

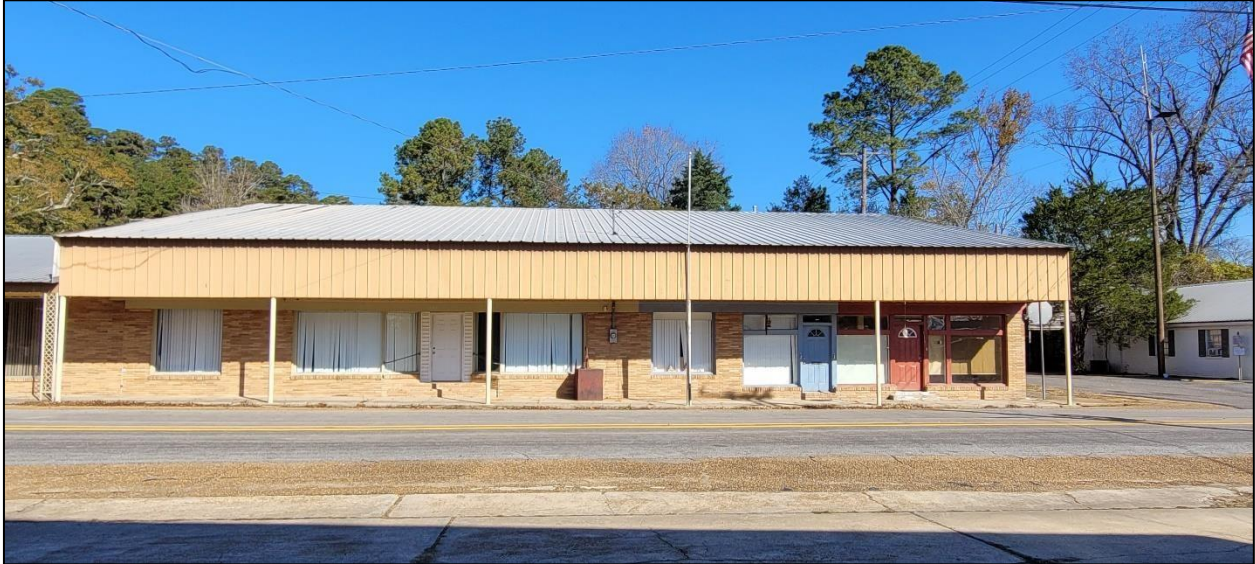
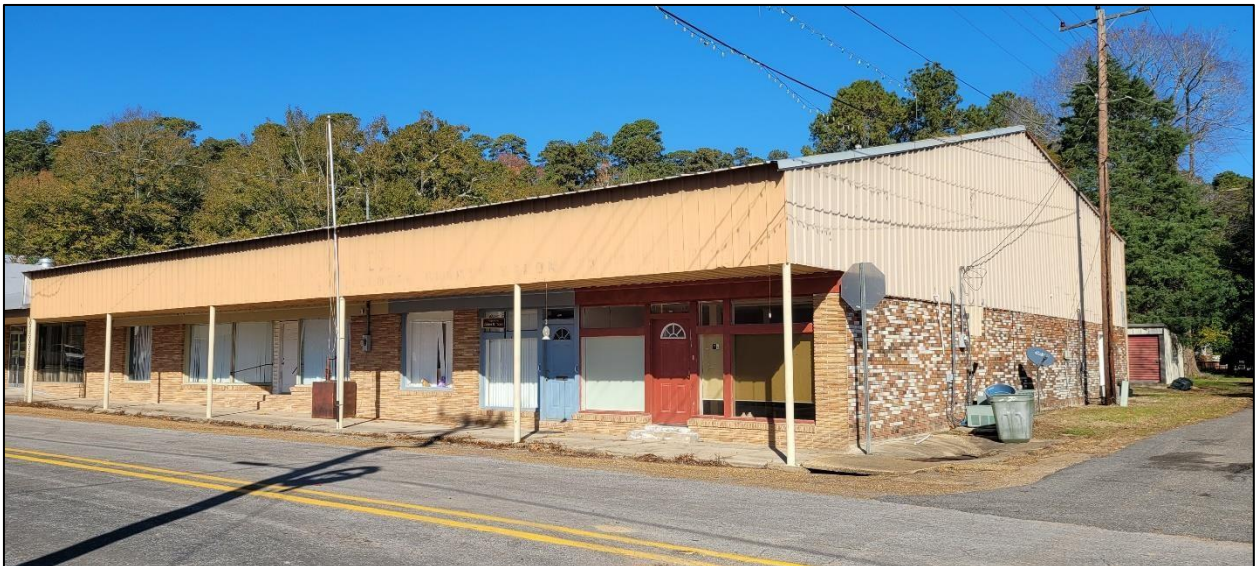
Figure 43. Structure 13-00591, facing north.

Structure 13-00591 is located at 200-201 Catahoula Street (Latitude: 31.772061, Longitude: -91.820080). The structure is a commercial row building constructed c. 1960 (Figures 43-44). The structure is a single-story commercial building laid on slab with a side gable roof clad in metal. The building is clad in running bond brick with metal vertical sheets in the gable ends. The full width incorporated front porch is supported by metal poles. The facade openings are commercial in style: large inoperable single pane windows (some with single pane transoms) and three paneled doors (two with fanlights).

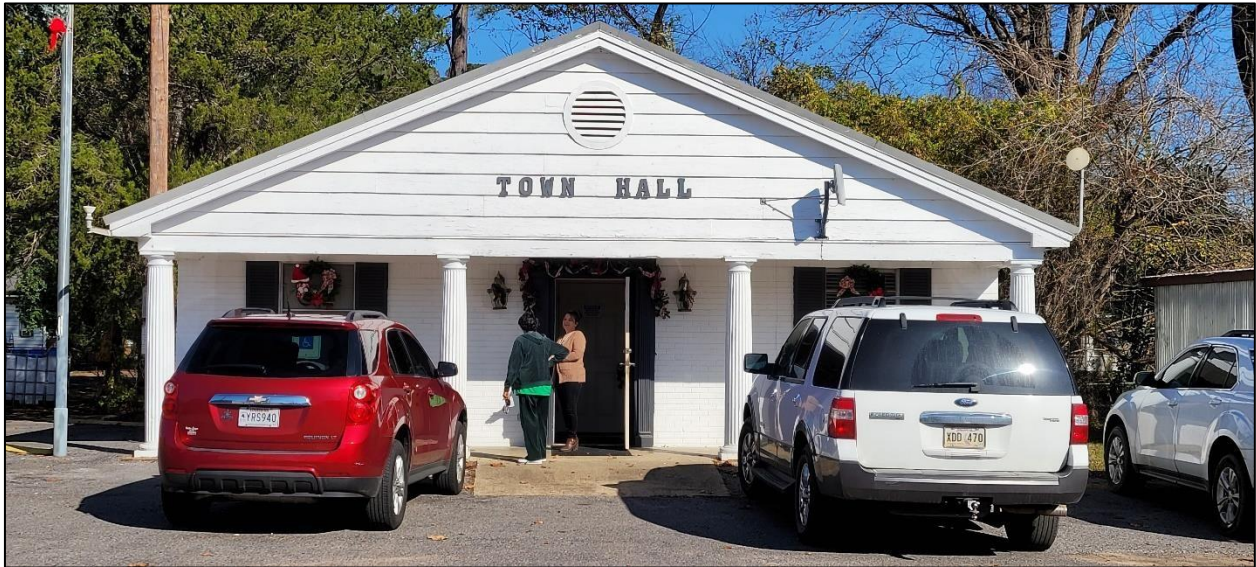
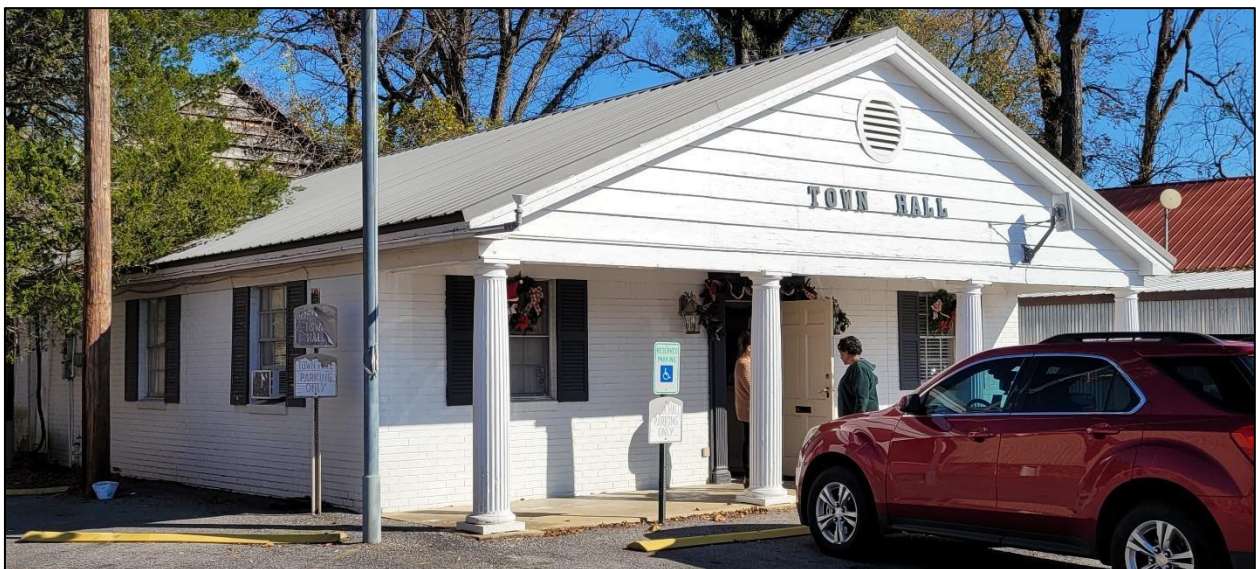
Figure 45. Structure 13-00592, facing north.

Structure 13-00592 is located at 198 Sicily Street (Latitude: 31.771997, Longitude: 91.819730). The structure is a free-standing commercial building constructed c. 1915 (Figures 45-46). The building has a front gable roof clad in metal and a full width front porch supported by Doric columns giving the appearance of a portico. The building is clad in running bond brick and has 6/6 aluminum windows and applied louvered shutters. The symmetrical building has a centered paneled front door.

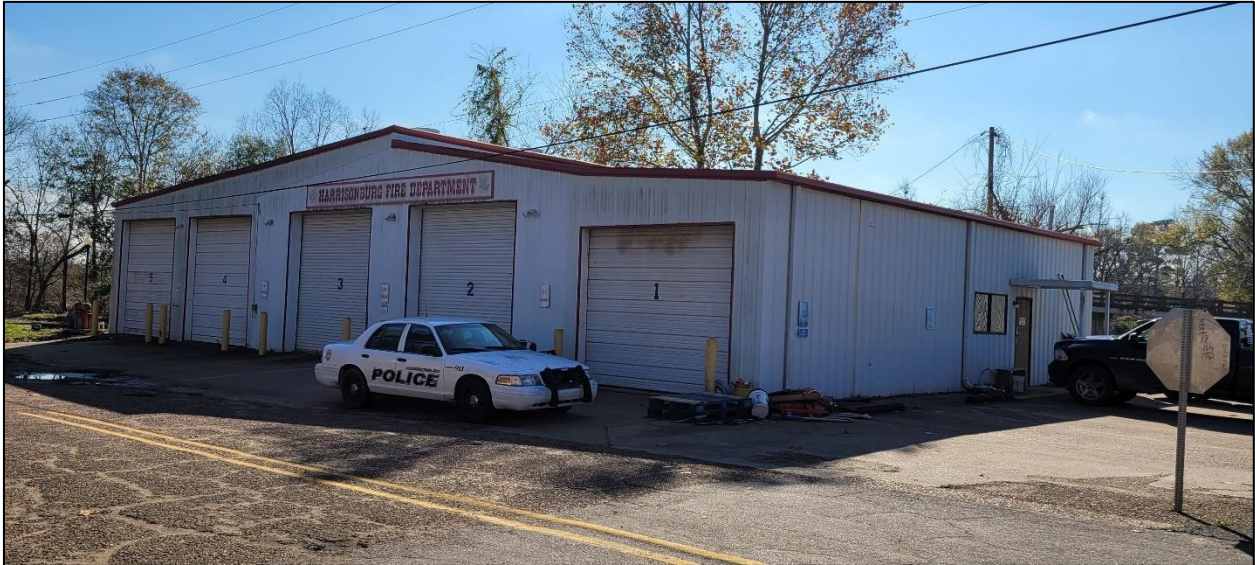
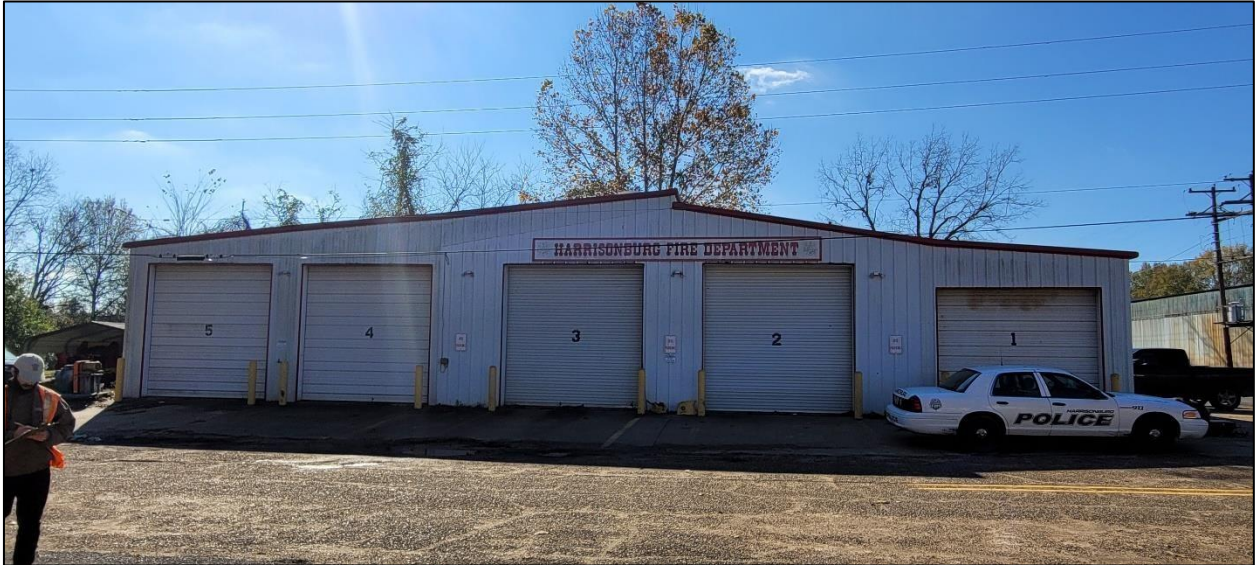
Figure 47. Structure 13-00593, facing southeast.

Structure 13-00593 is located at 108 Sicily Street (Latitude: 31.771655, Longitude: 91.819673). The structure is a warehouse building constructed c. 1950 (Figures 47-48). This structure is the Harrisonburg Fire Department. This is a metal clad building with a low-pitched metal roof and is laid on slab. The façade has 5 roll up bay doors (each with a number 1-5) to house the fire engines. The side elevation entrance has a flush door under a flat metal awning and a 1/1 window.

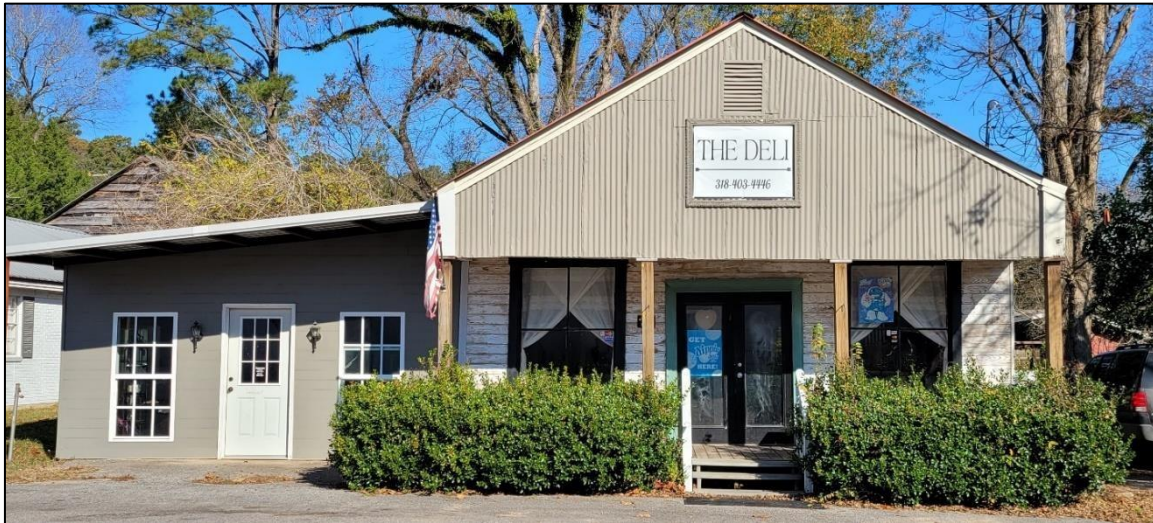
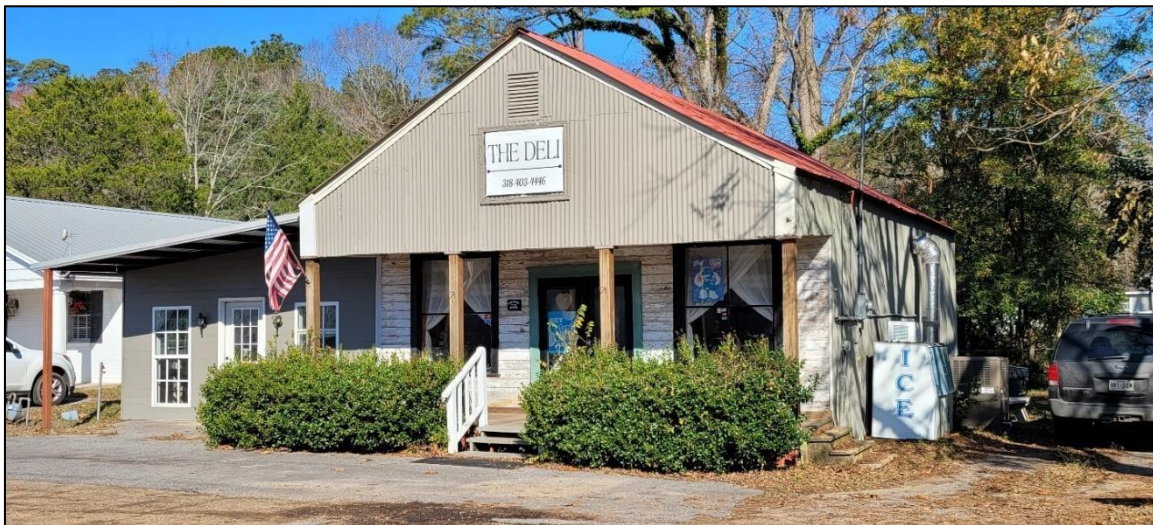
Figure 49. Structure 13-00594, facing north.

Structure 13-00594 is located at 104 Sicily Street (Latitude: 31.771933, Longitude: 91.819580). This structure is a freestanding commercial building constructed c. 1915 (Figures 49-50). This structure is present on the 1919 Sanborn Map. The structure has a front gable roof clad in metal with metal sheets covering the gable end. There is a full width incorporated front porch supported by wood posts and accessible via wood steps with a wood railing. Large four pane wood windows on either side of a set of single pane front doors/ A side elevation concrete block addition has a shed roof, is laid on slab. Has 6/6 vinyl windows and a pane over the panel metal door.

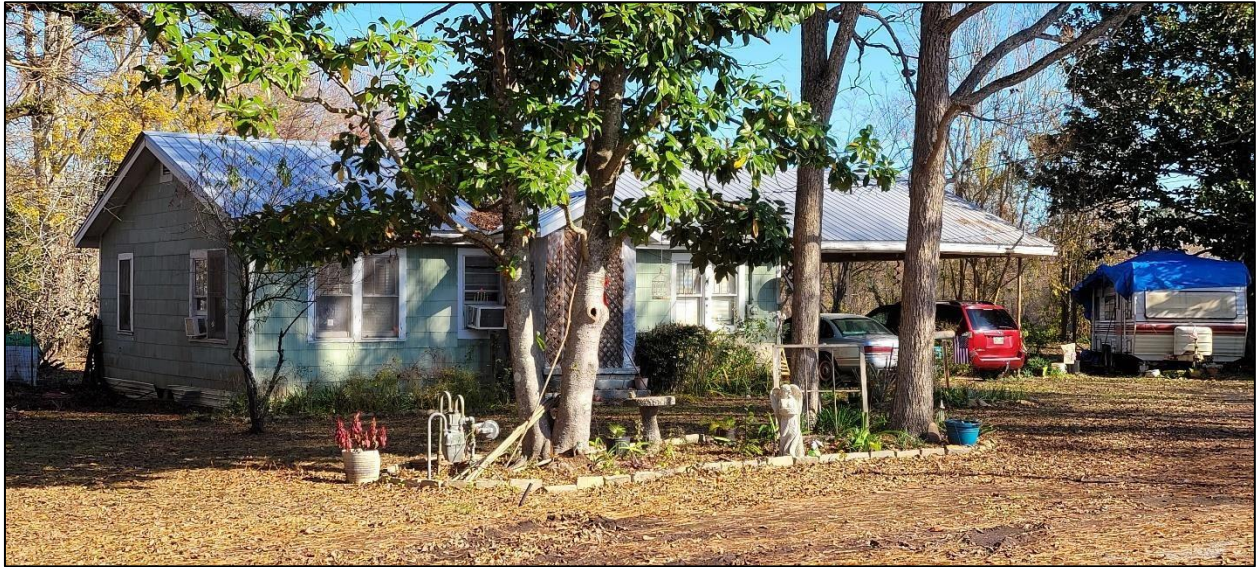
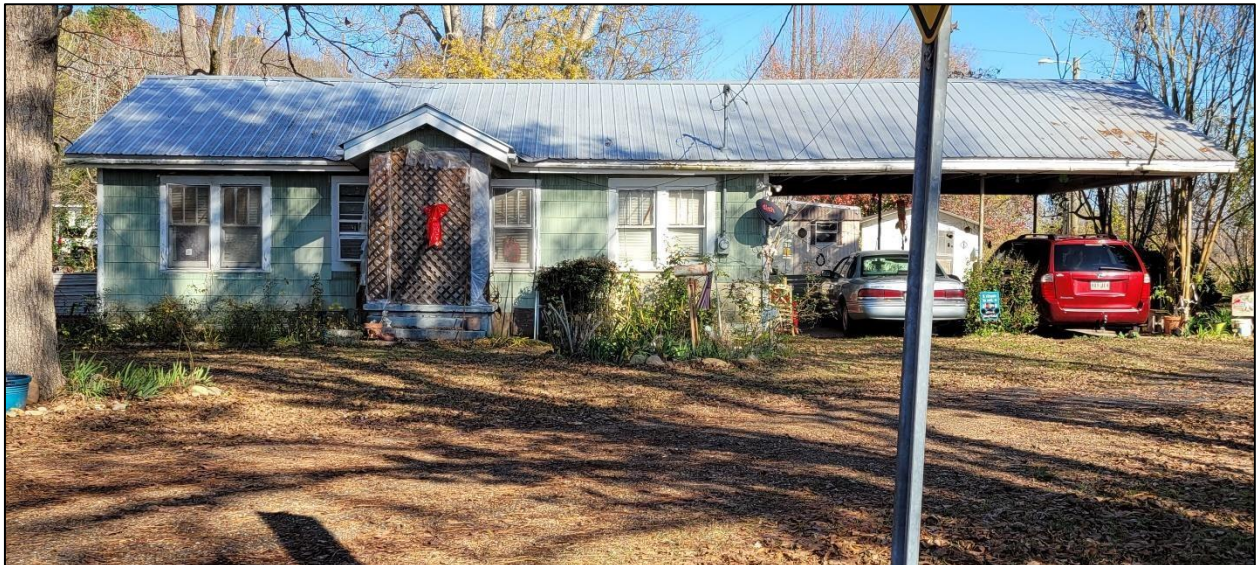
Figure 51. Structure 13-00595, facing northeast.

Structure 13-00595 is located at 100 Sicily Street (Latitude: 31.771945, Longitude: 91.819199). The structure is a minimal traditional cottage constructed c. 1940 (Figures 51-52). The building features a side gable roof with small façade gable over the front entry porch. The roof is clad in metal with boxed eaves. The front porch is covered by lattice and plastic. An incorporated carport is supported by metal poles. The house is clad in asbestos siding, has 3/1 dh wood windows with exterior screens. The foundation of the elevated house is unknown.

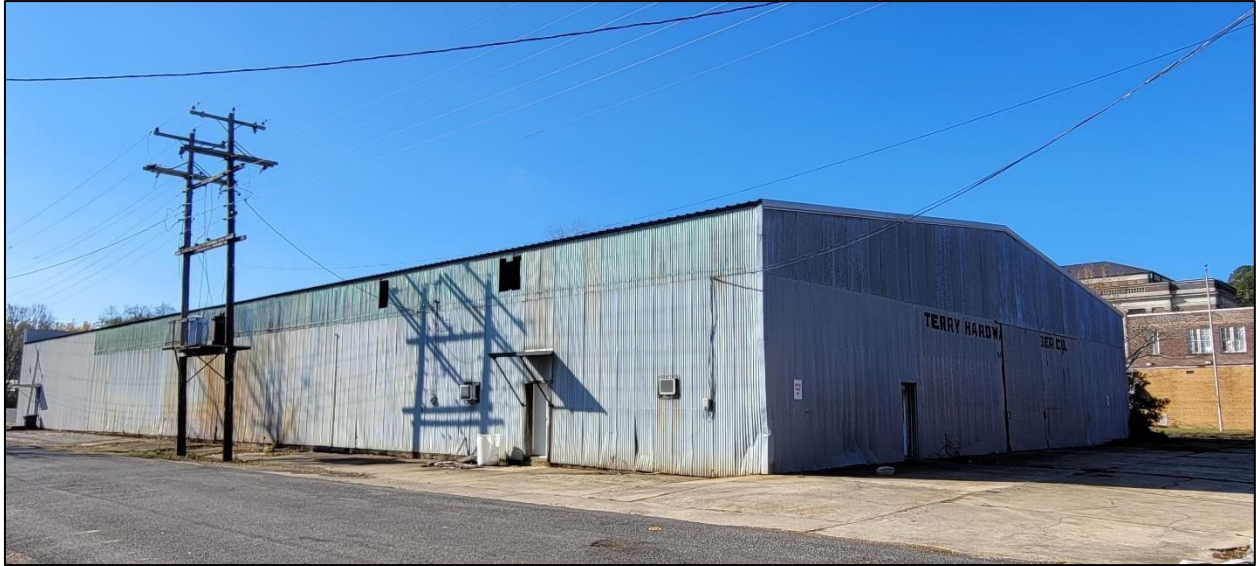
Figure 53. Structure 13-00599, facing west.

Structure 13 - 0599 is located at 102 Pine Street (Latitude: 31.771430, Longitude: 91.820301). The building is a warehouse constructed c. 1970 (Figure 53). The building has a front gabled roof clad in metal. The building is also clad in metal and laid on slab; it has no windows and three entry doors, two of which are under metal awnings. A large sliding bay door sits on the façade under a painted sign that reads “Terry Hardware & Lumber Co.”
