**PHASE I CULTURAL RESOURCES SURVEY OF
2.31 ACRES (0.94 HECTARES) NEAR
HARRISONBURG, CATAHOULA PARISH,
LOUISIANA**

Final Report

February 2021

**Surveys Unlimited Research Associates, Inc. P.O.
Box 14414
Baton Rouge, Louisiana 70898-4414**

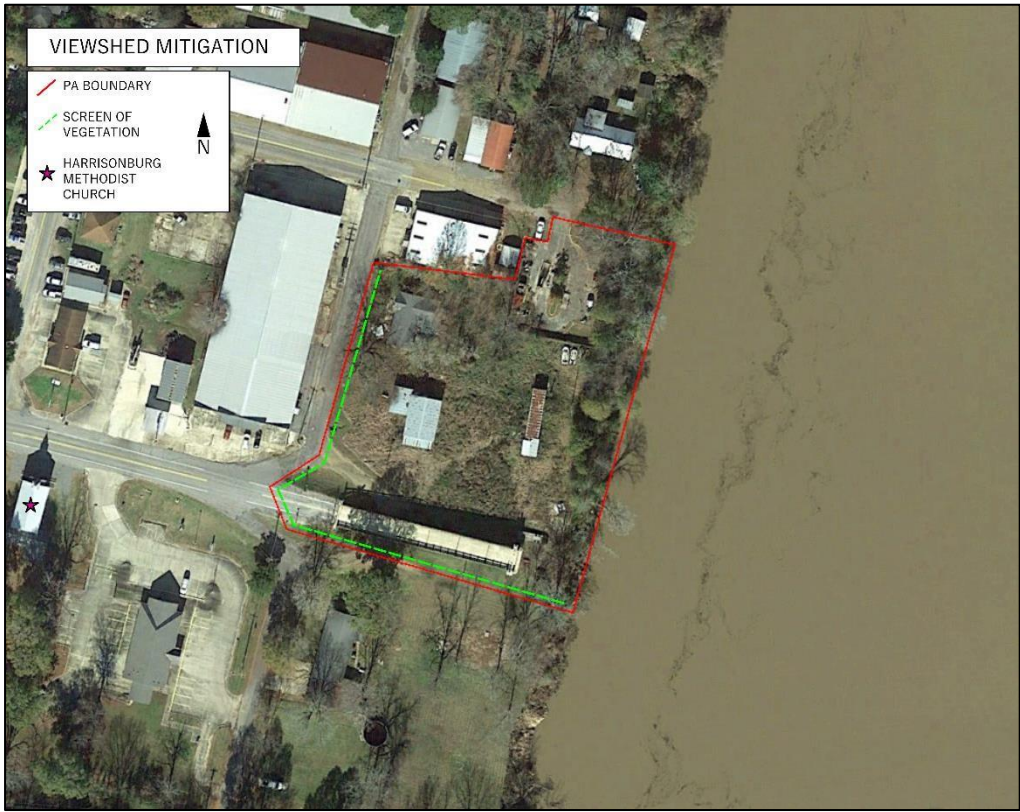
Figure 54. Suggested location of vegetation screen for viewshed mitigation.

Although no sites identified within the PA are eligible for inclusion on the NRHP, development within the PA may alter the viewshed of the Harrisonburg Methodist Church (Resource ID No. 13-00596), a property listed on the NRHP. For this reason, the authors recommend that the developers should consider erecting a screen of vegetation (trees or shrubbery) along the southern and western boundaries of the PA (Figure 54).
